SEATTLE-TACOMA
INTERNATIONAL AIRPORT

Sound Insulation Repair and Replacement Pilot Program:
Assessment Technical Report

JANUARY 2025

Environmental Science Associates

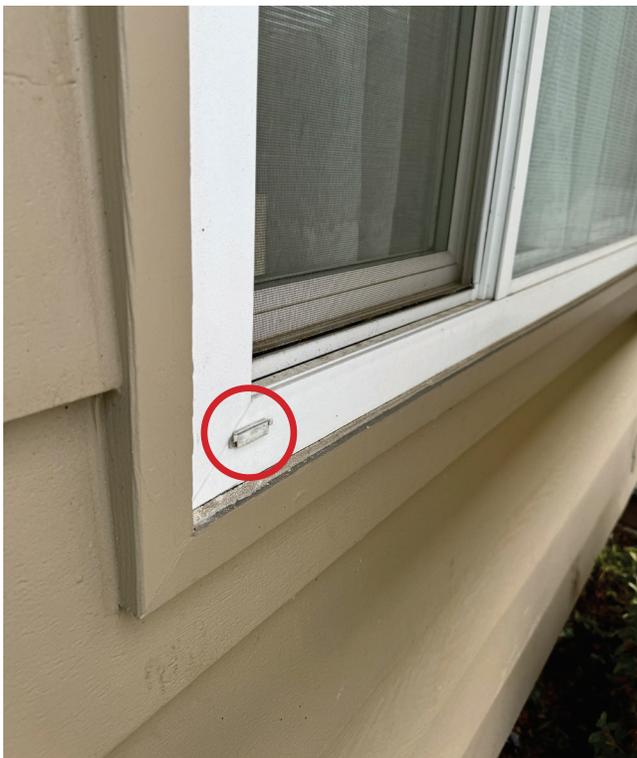
Exterior image of an Alpine (STC35) window with weephole (circled in red).

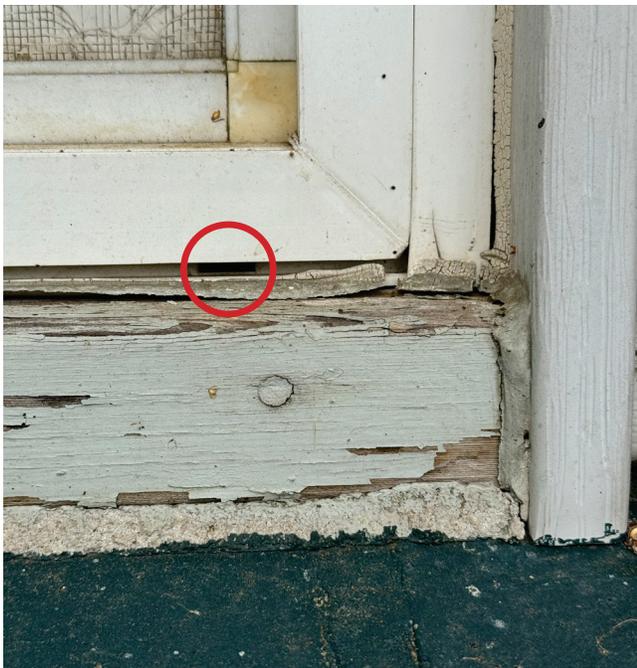
Exterior image of an Alpine (STC44) window with weephole (circled in red) covered by caulking and frame damage.

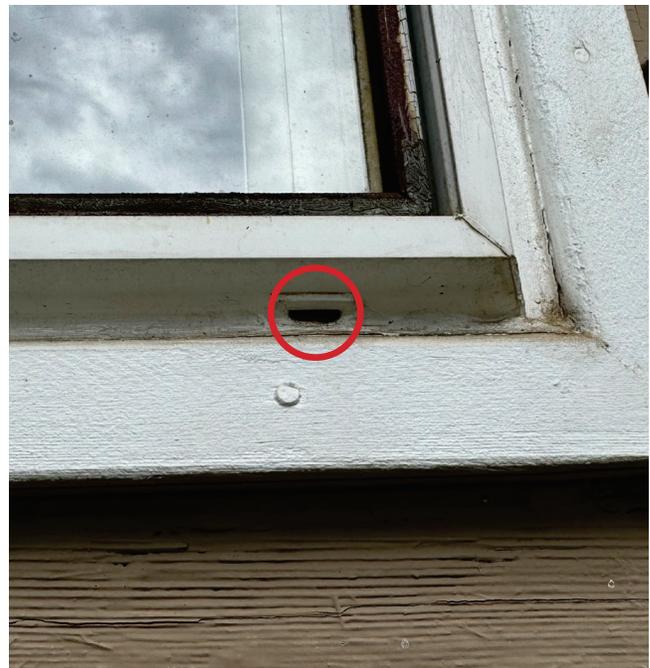
Exterior image of a Alpine (STC44) window with weephole (circled in red).

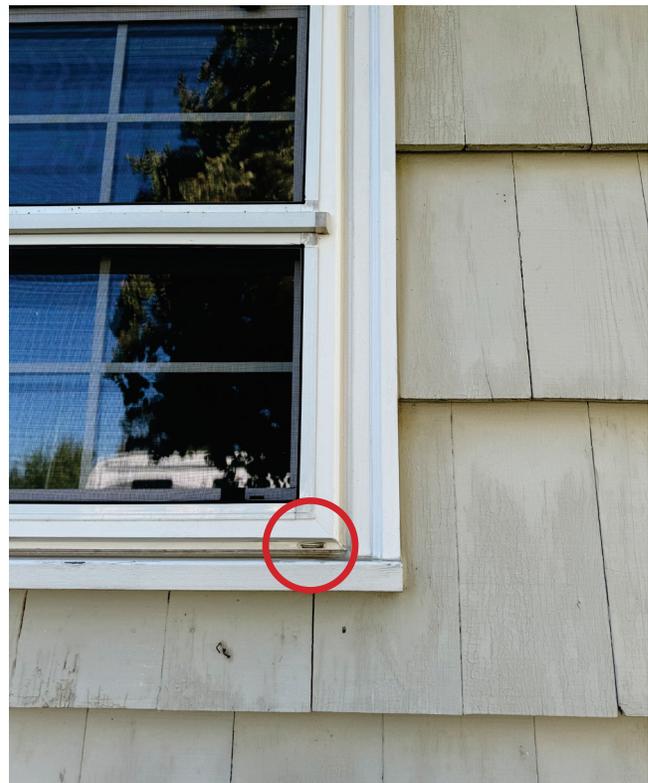
Exterior image of a Milgard window with weephole (circled in red).

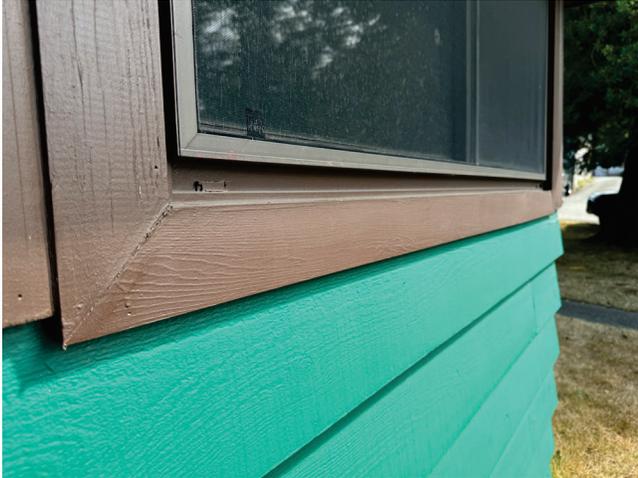
Photo of window with sill painted over.

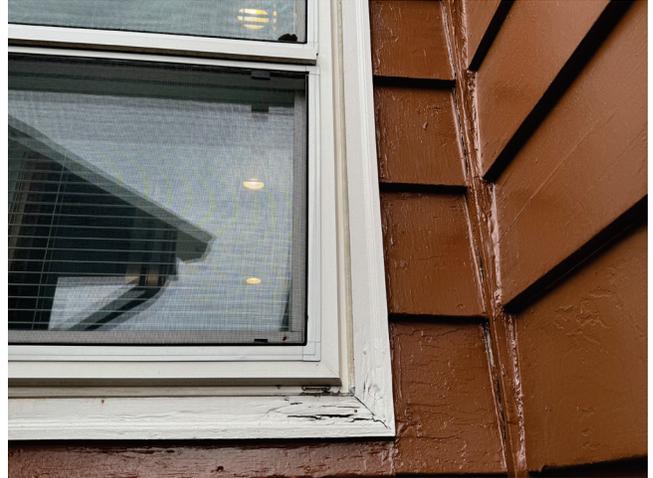
Photo of window trim deterioration.

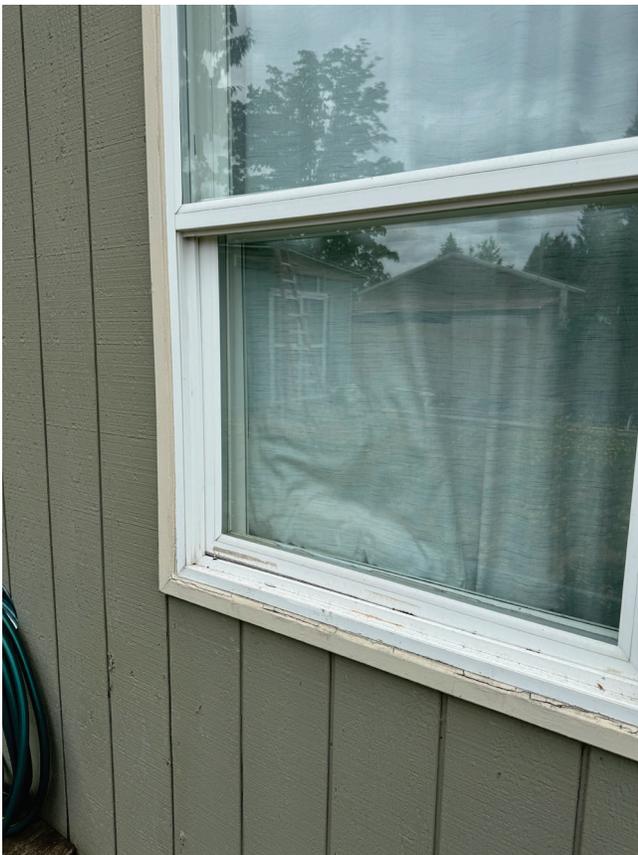
Image of window balancer issue.

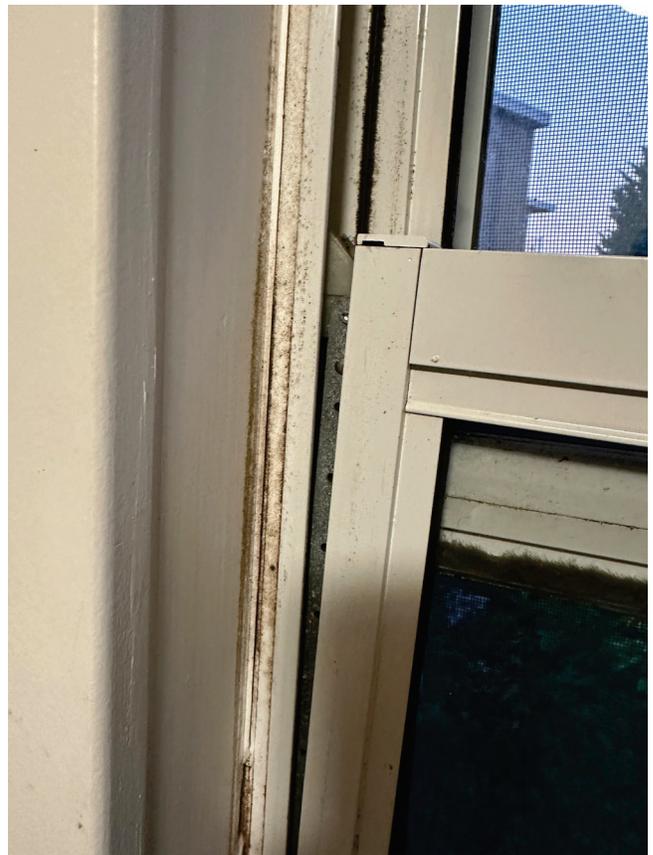
Image of window balancer issue.

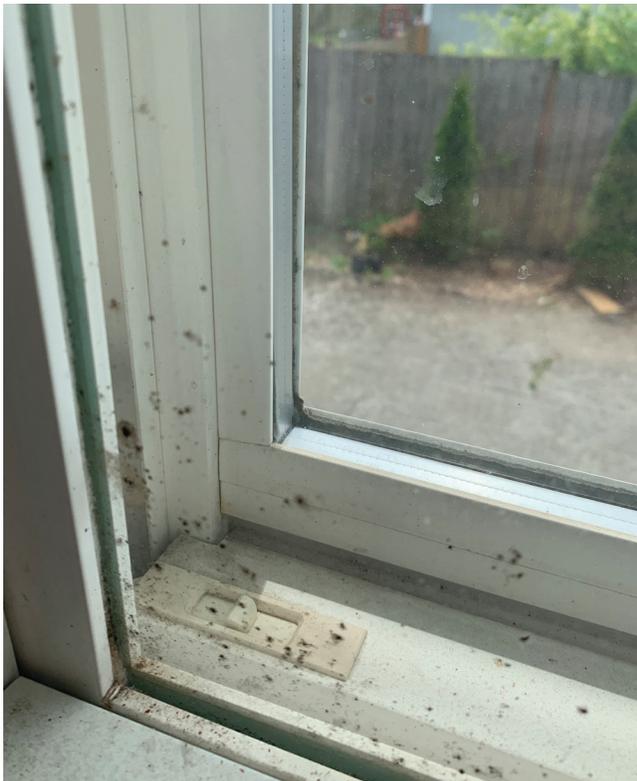
- **Field Assessment** - Moisture was noted on numerous window packages and sliding doors. Window weeps were also found to have been covered by paint or caulk-closed due in part to the design and location of the weephole. When the weephole is covered, water is able to back up into the unit and slowly drain into the trim work and may cause deterioration of the trim and/or siding along with causing the caulking to release. In two instances in which the owner noted musty/moldy conditions in the winter months, it was in locations in which there was a non-mechanical vent present as a potential moisture pathway.

Interior image of a window with possible mold.

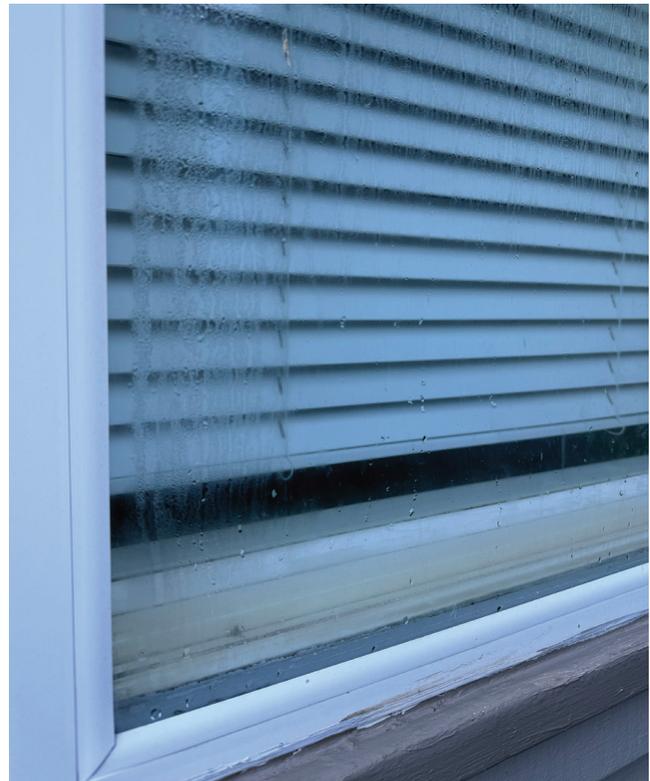
Exterior image of a window with covered weephole and condensation between glass.

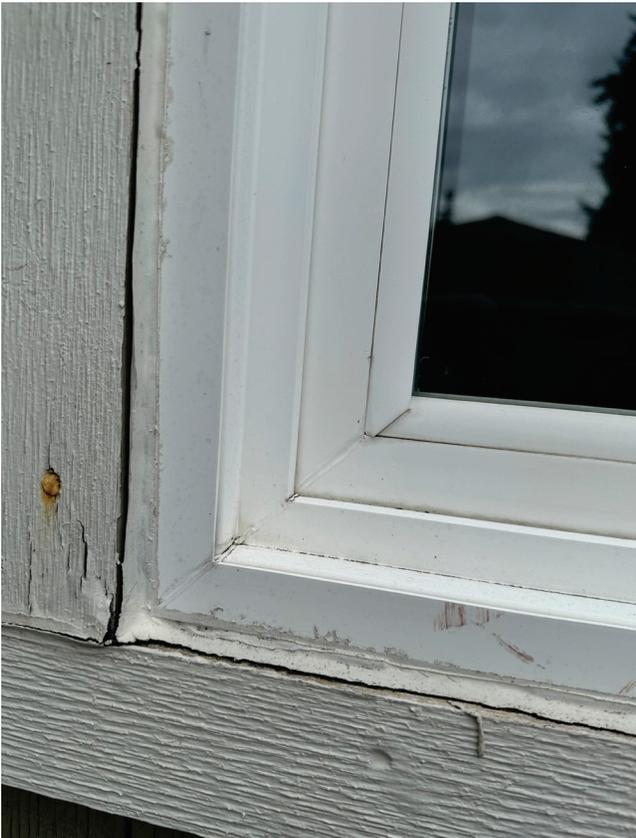
Exterior image of a window with trim damage.

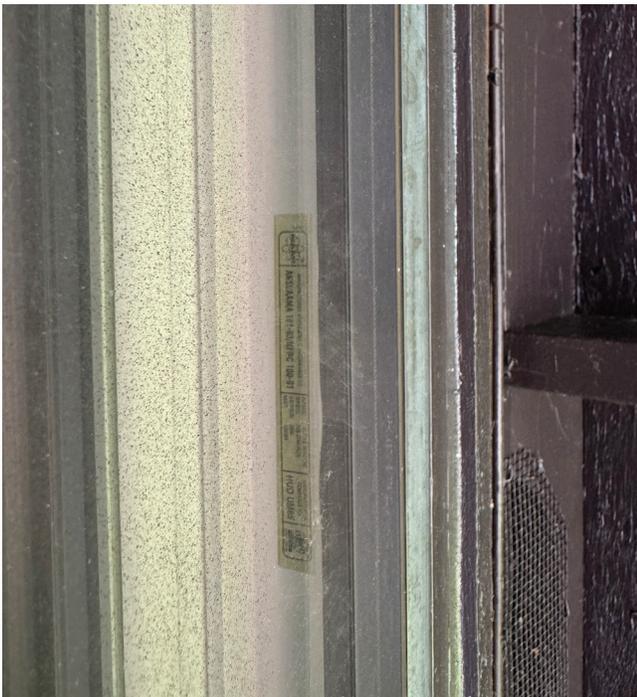
- **Field Assessment** - Multiple challenges were found in the ability to clean and maintain the product. The design of the product(s) created areas that could not be accessed behind fixed storm panels. Picture windows, sliding patio doors and sliding windows with a fixed side all created areas in which neither the owner nor a professional window cleaner could access and clean.

Image of a window with debris between windowpanes.

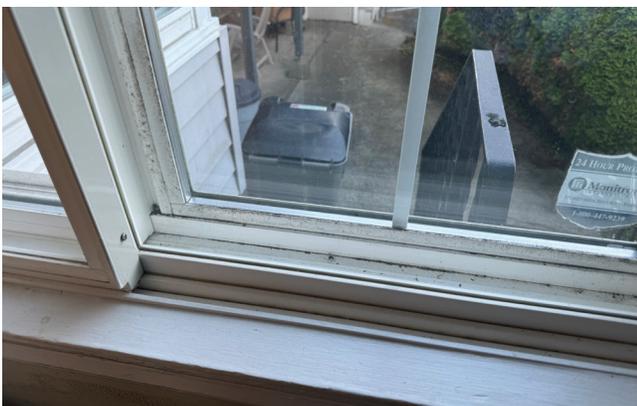
Image of a window with debris between fixed storm windows.

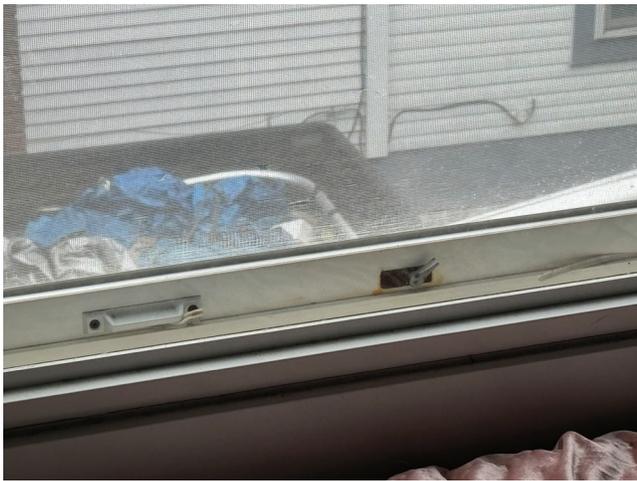
Image of a window with broken/corroded locks.

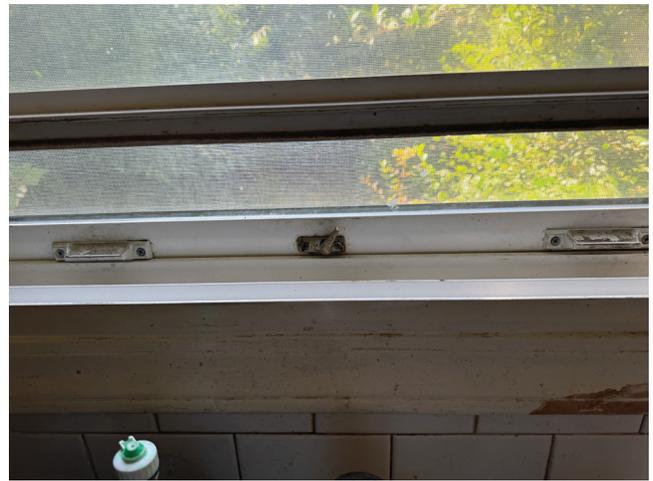
Image of a window with broken/corroded locks.

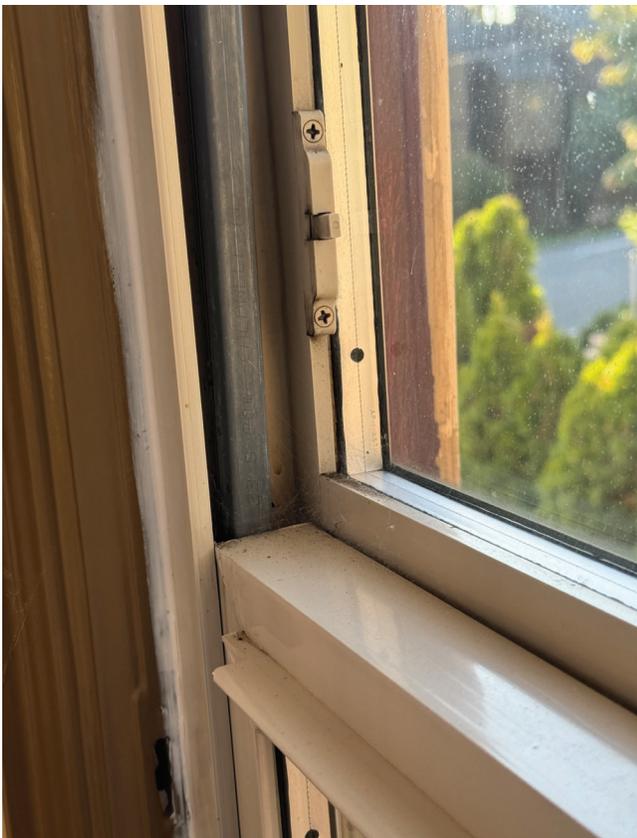
Image of single/double hung window with broken balance.

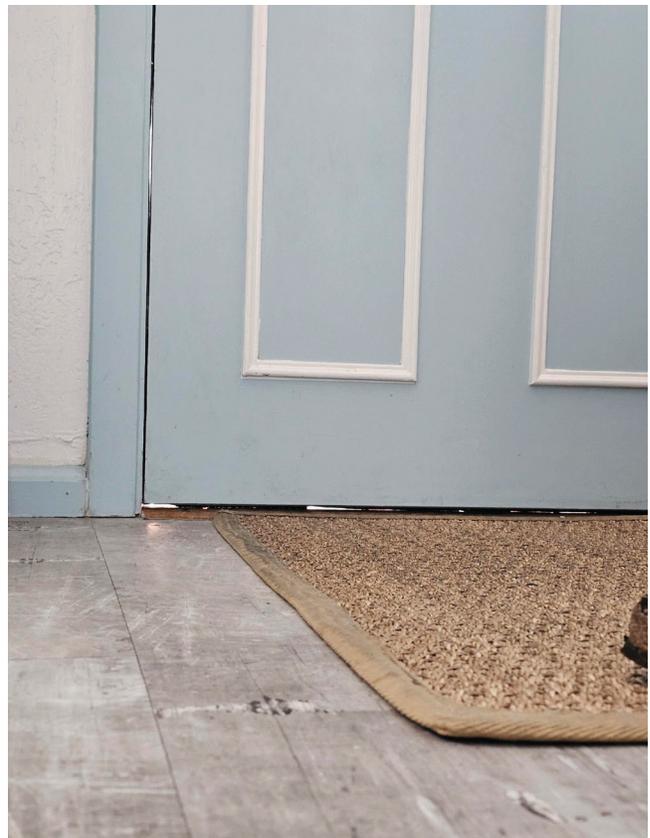
- **Field Assessment** - Entry doors were found to be out of square or plumb or had visible light coming from the top, bottom, or strike plate side of the door jamb. In most cases, the weatherstripping was either damaged or missing. In most homes the entry doors and sliding patio doors appeared to be the original to the home and were not a part of the sound insulation packages. The door scope was the addition of storm doors to entry and sliding patio doors. With single and double-hung windows in which the balancers were broken, the windows did not fully close and were a source of noise and air penetration.

Image of an entry door with poor insulation.

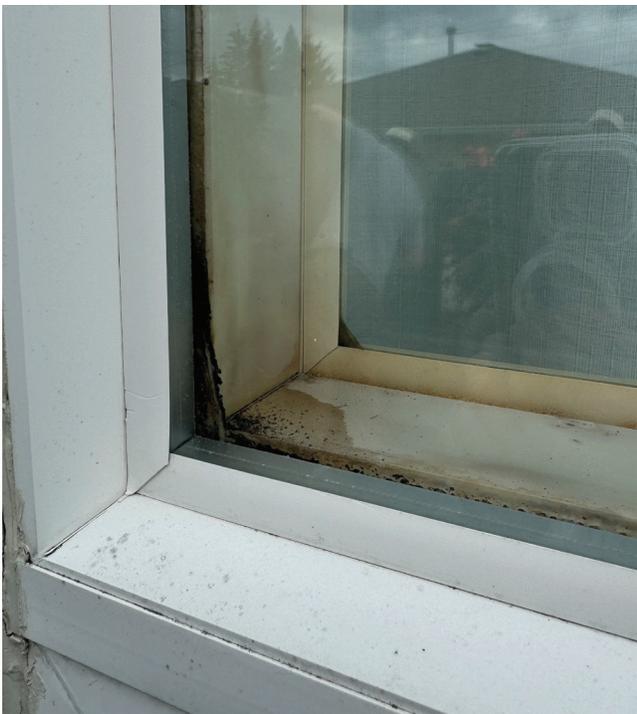
- **Field Assessment** - Issues found with screws set at the bottom of jamb, or piercing the sill down into the frame which allows water pooled within window to seep around screw, promoting water damage in wood framing and rusting/corroding the locking device. In cases in which the weepholes were caulked over, trim was found to be deteriorated.

Photo of window deterioration.

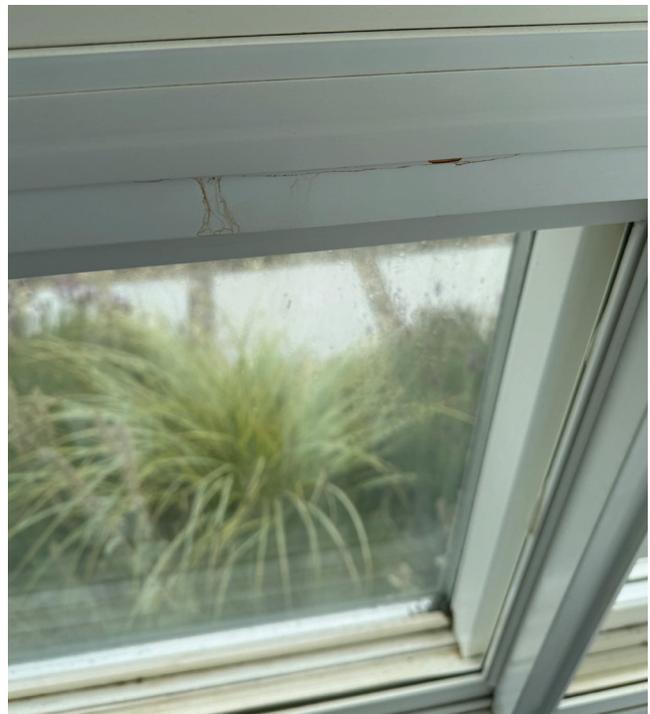
Photo of window with mull leak and trapped debris.

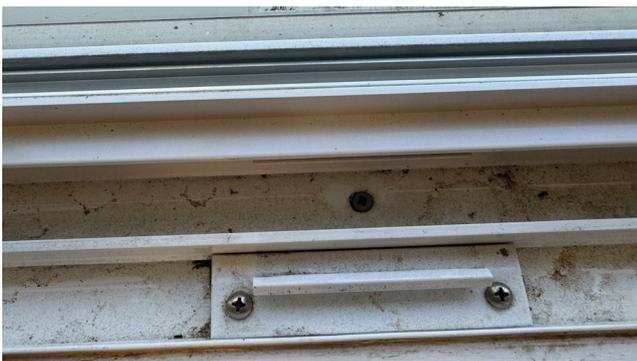
Image of screw installed in sill.

A key installation failure by the contractor was noted on double hung windows. In 33 of 70 instances, the contractor installed them by setting a screw in the sill, thereby promoting water damage in the wood framing and rusting/corroding the locking device and balancers over time.
