SEATTLE-TACOMA
INTERNATIONAL AIRPORT

Sound Insulation Repair and Replacement Pilot Program:
Assessment Technical Report

JANUARY 2025

Environmental Science Associates

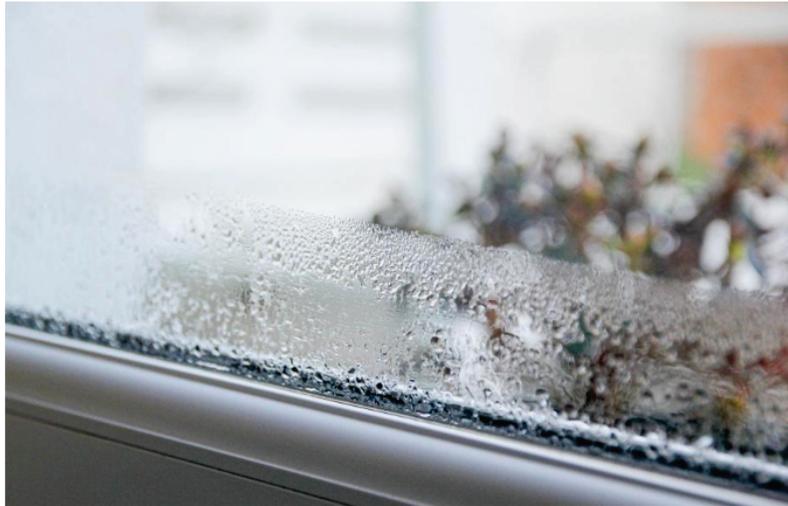
Is your glass “sweating” – is water beading or ice forming on the inside surface of your windows? There’s a good chance that what you are seeing is condensation, a sign that there is excess humidity in your home. Humidity – water vapor mixed with air – is drawn to the coolest surfaces, such as your window. Cool air cannot hold as much moisture as warm air, so windows and doors often collect this moisture and make it visible. A surface that is cooler than room temperature is more likely to show condensation. Condensation is not a product defect. If you have excess condensation, please explore ways to limit humidity and regularly clean surfaces.

Indoor moisture is caused by a variety of factors, including cooking, showering, running dishwashers, storing firewood, pets, fish tanks, plants, clothes dryers that are not vented properly, even breathing. Your new windows are most likely showing condensation more than your old ones because they are more airtight – less air is entering your home from the outside. The air leaking from older windows evaporated the moisture before it could collect.

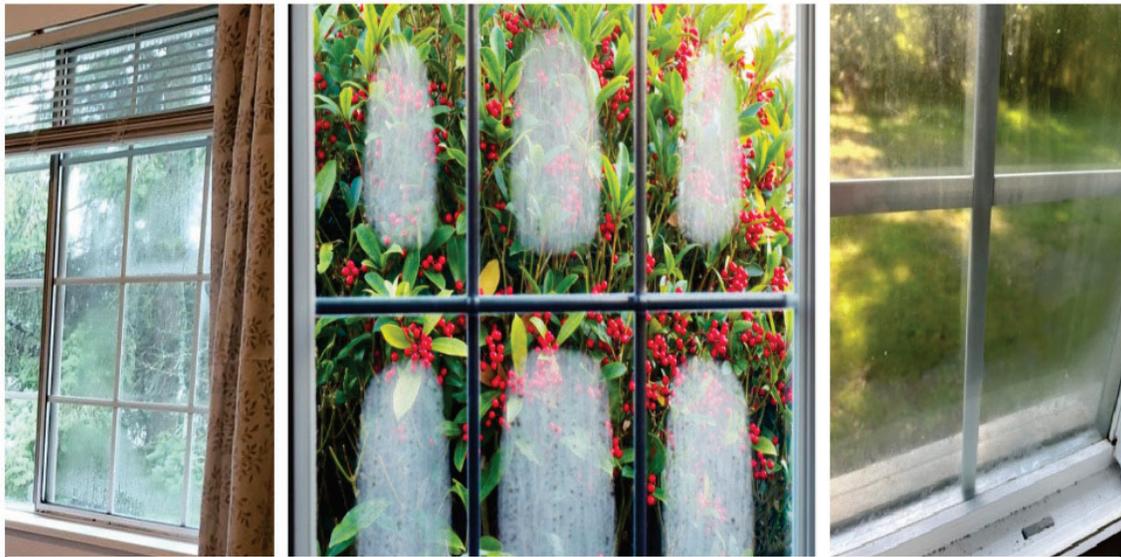
Your windows have an insulated glass unit (IG) that consists of two panes of glass with a metal spacer in between them that are adhesively sealed to the spacer. If the adhesive seal breaks or releases, air and moisture can enter the space between the 2 panes of glass. When this happens, you might start to notice fogging, moisture and streaking between the panes of glass.

This defect is called a Seal Failure. Because this condition is in between the panes of glass, you are not able to wipe them away.

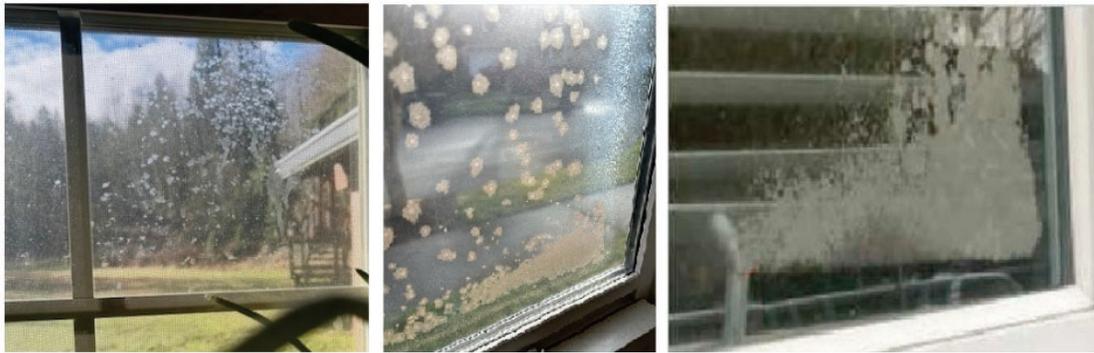
If the LoE coating fails, you will start to see small spots appear in between the 2 panes of glass. Because this condition is in between the panes of glass, you are not able to wipe them away. Over time, the spots will grow as more of the microscopic, metallic oxide fails; the small spots will become larger areas over time.

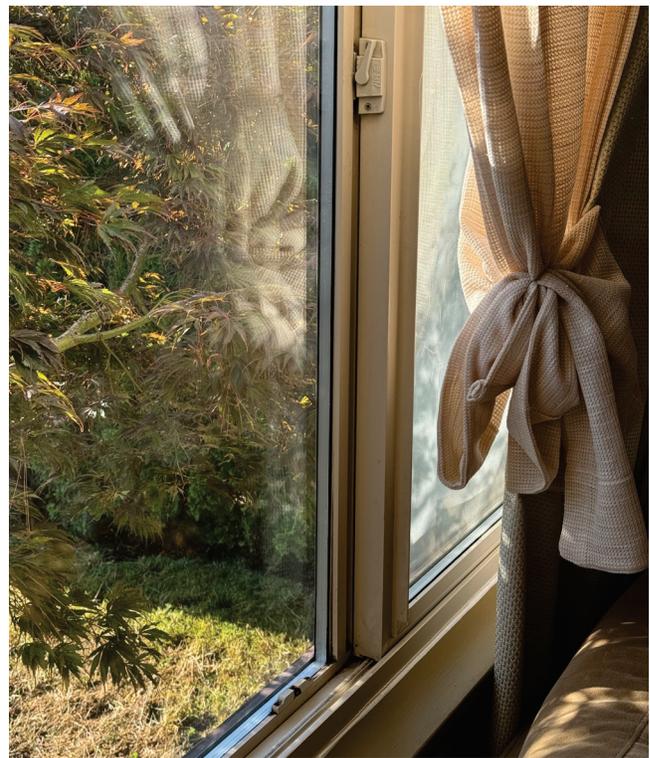
Interior image of an Alpine (STC35) window.

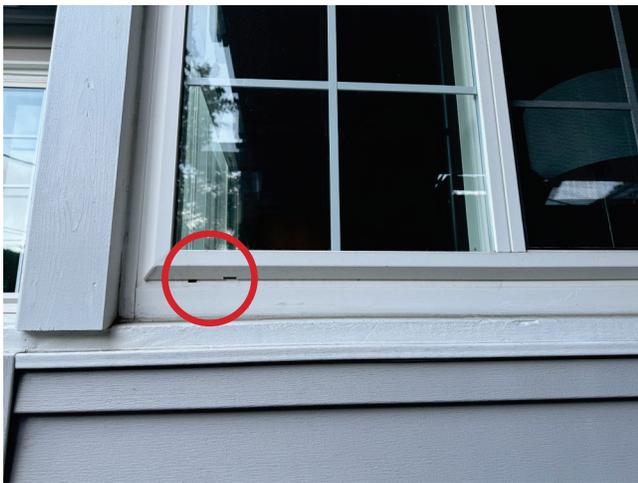
Exterior image of a CDI (STC44) window with dual weephole (circled in red).

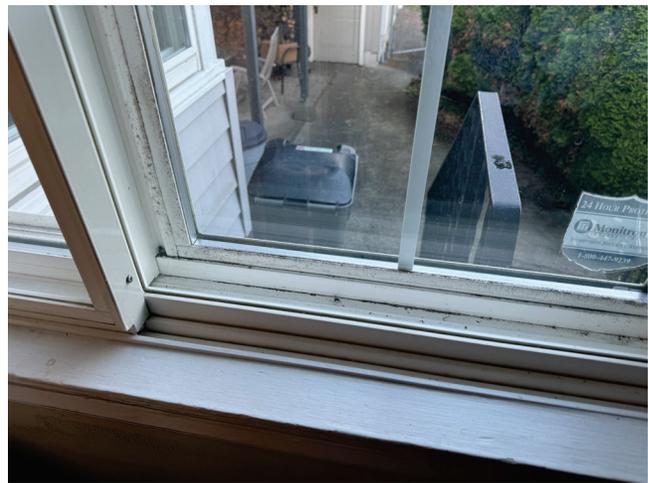
Interior image of a CDI (STC44) window.

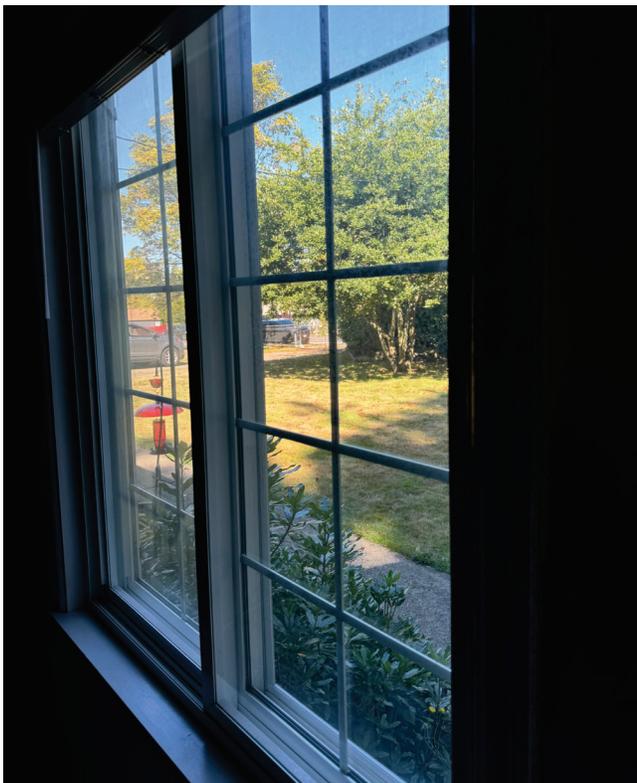
Interior image of a Milgard window.

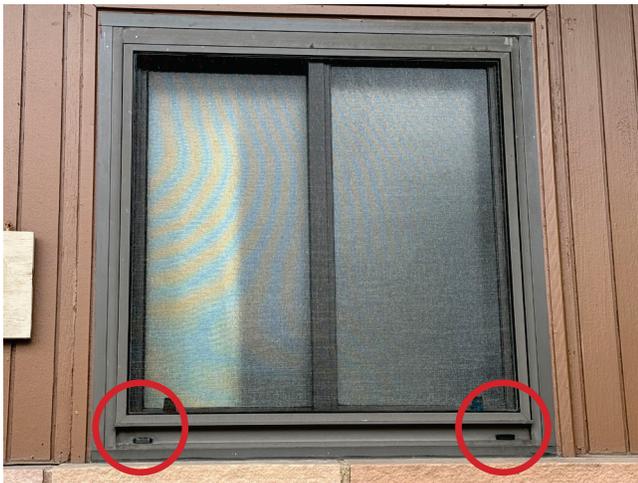
Exterior image of a Peerless/DeVac window with two weepholes (circled in red).

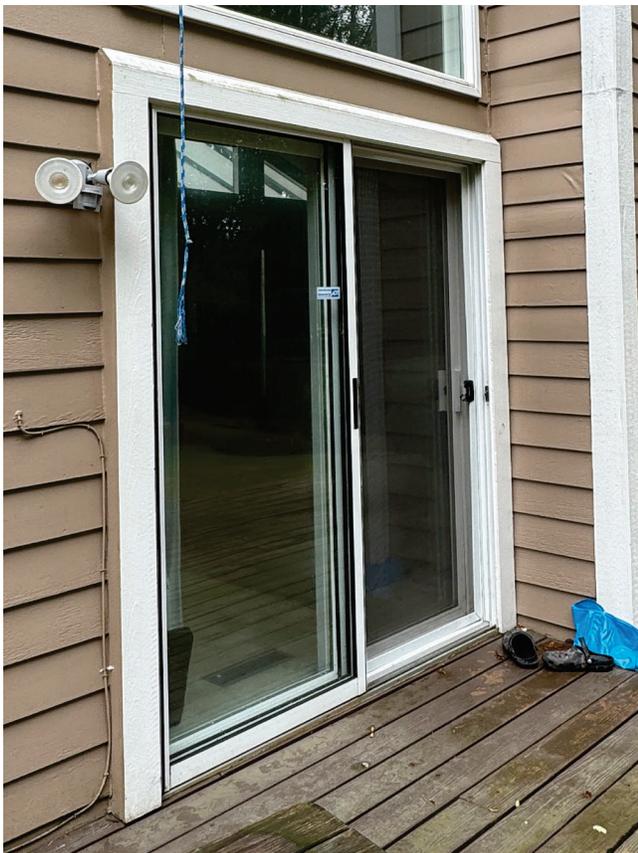
Exterior image of a sliding door with storm.

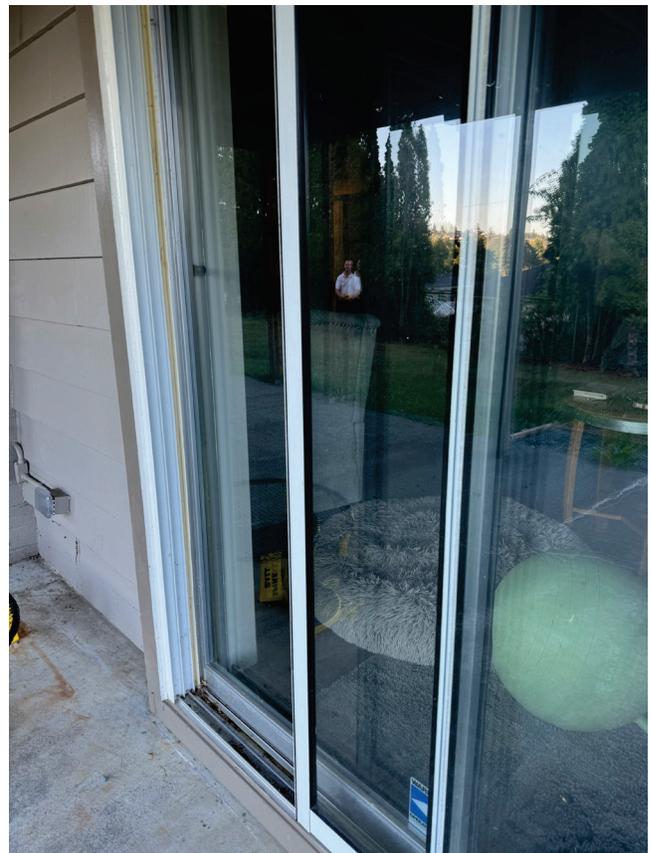
Exterior image of a sliding door with storm.

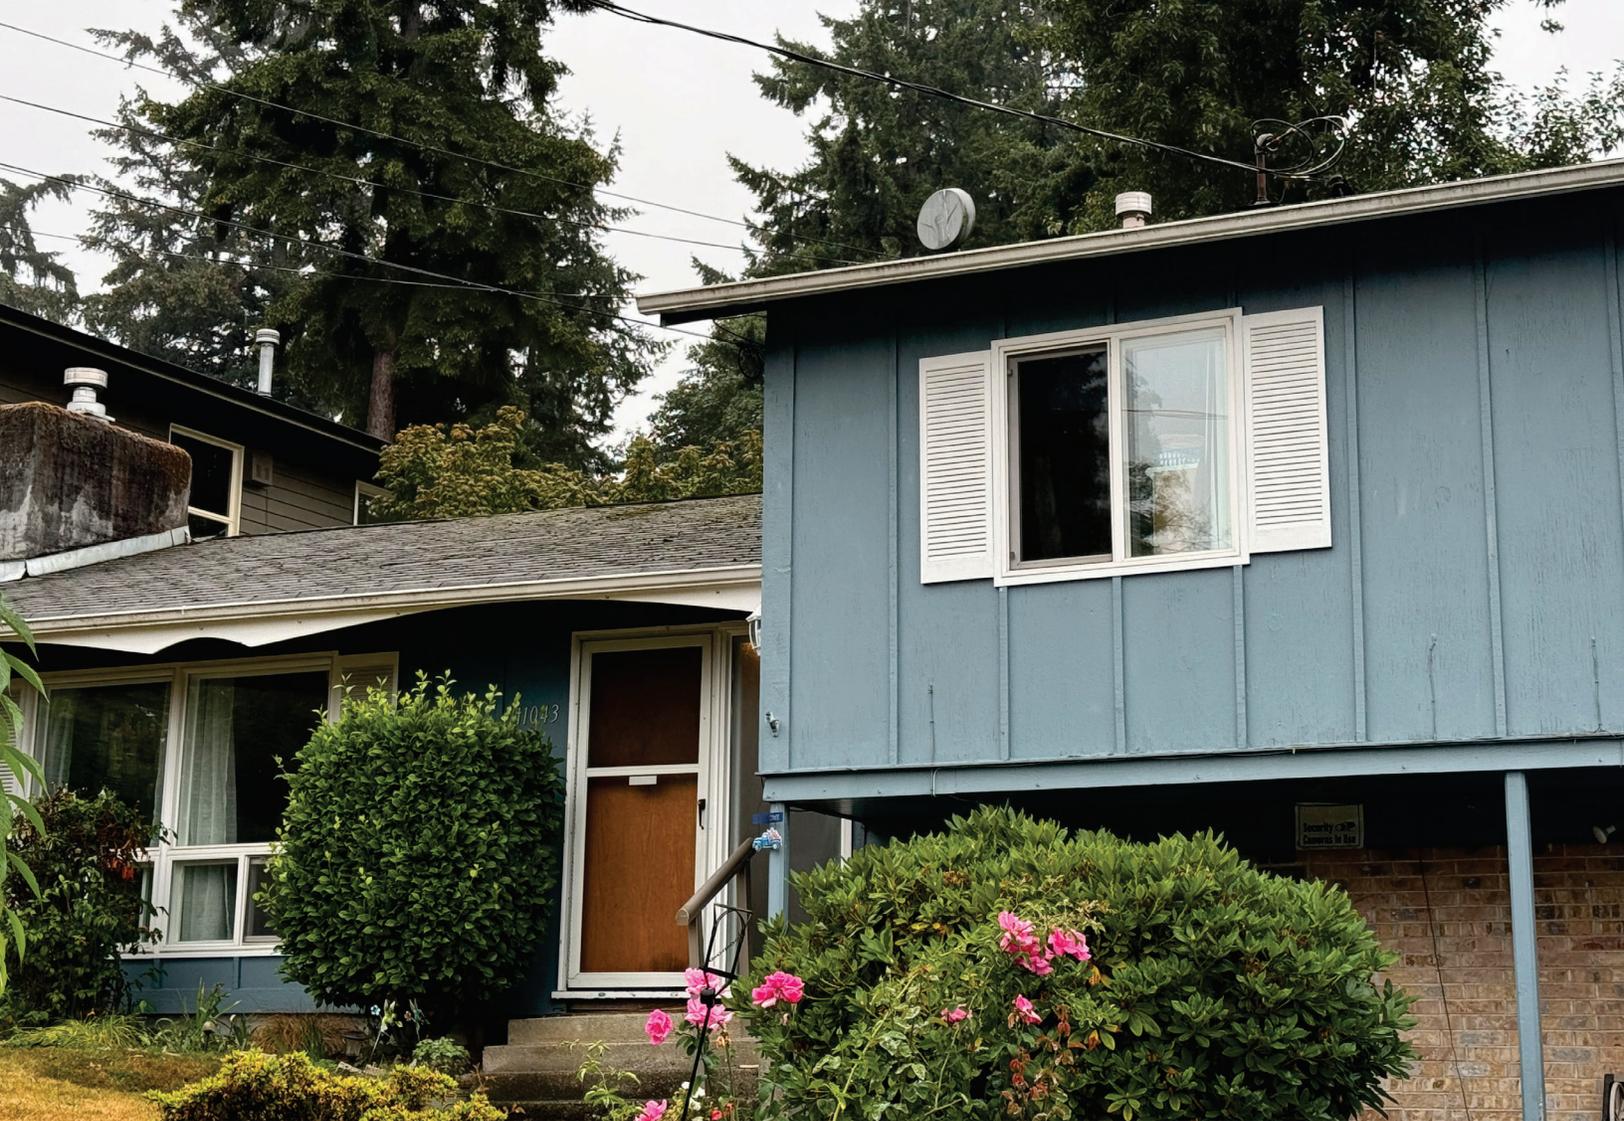
Image of window original entry door with added storm door.

The assessment of entry doors and sliding doors found that most had not been replaced as part of their original sound insulation work. The work performed was generally to add a storm system to the existing product. With entry doors, 81% (with or without storm door) were out of square (structurally misaligned) or plumb (i.e. not straight) or had visible light coming from the top, bottom, or strike plate side of the door jamb. In most cases, the weatherstripping was either damaged or missing. This finding, however, cannot be attributed to any Port program product, as most entry doors are original to the house.

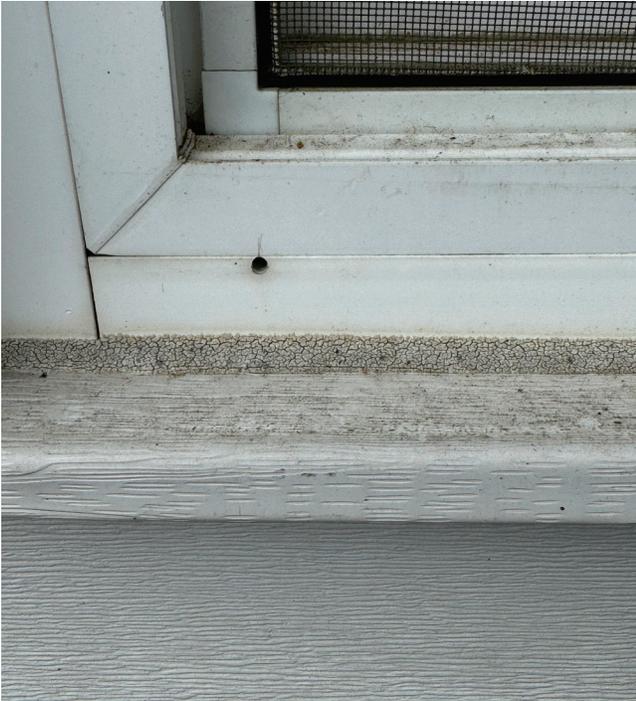
Exterior image of a window with weephole.

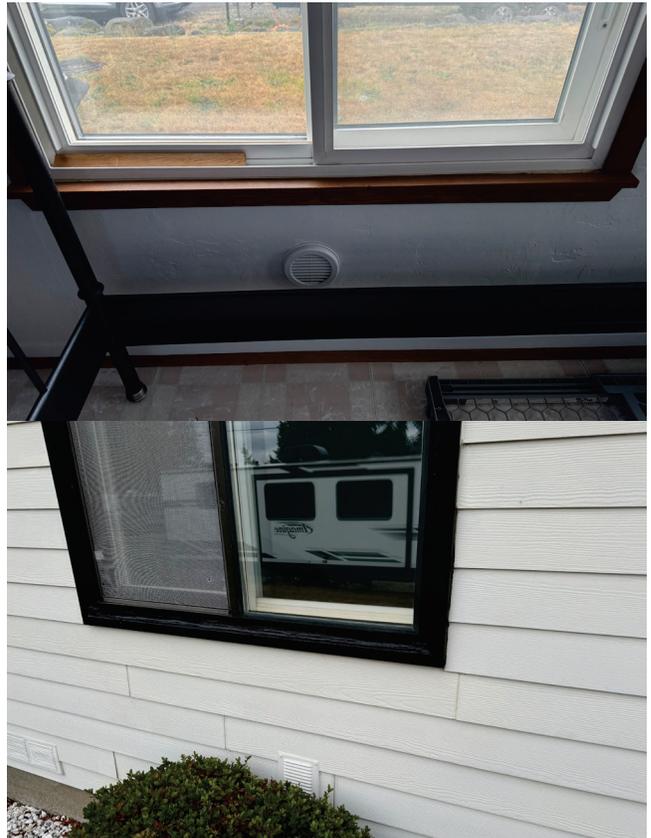
The ventilation system identified in the homes were non-mechanical vents. This consisted of an exterior vent covering a 4-inch pipe to the interior. The interior cap varied from a fixed cap to a movable cover to regulate the flow of fresh air into the structure. In two homes, the resident noted that in the winter months the wall upon which the non-mechanical vent is installed becomes musty and moldy.

Interior (upper) and exterior (lower) image of fresh air vent path.

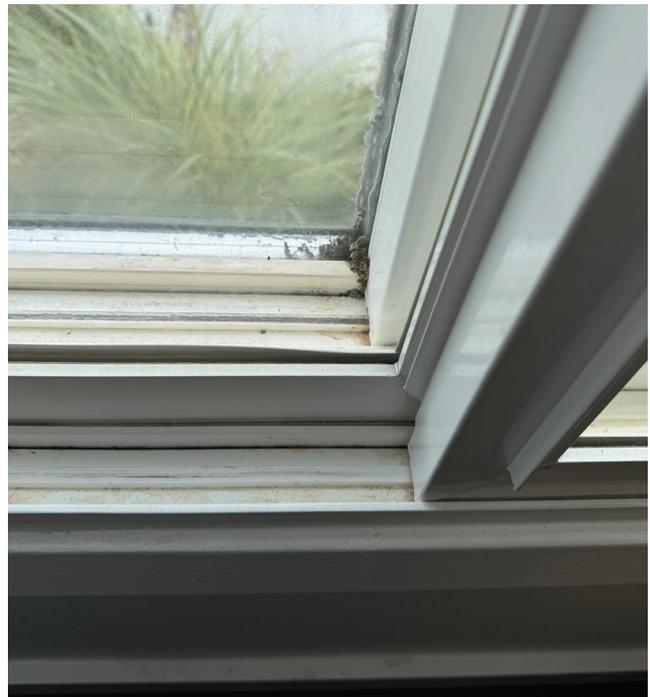
- **Field Assessment** - Multiple challenges were found in the ability to clean and maintain the product. The design of the product(s) created areas that could not be accessed behind fixed storm panels. Picture windows, sliding patio doors and sliding windows with a fixed side all created areas in which neither the owner nor a professional window cleaner could access and clean.

Image of a window with debris between windowpanes.

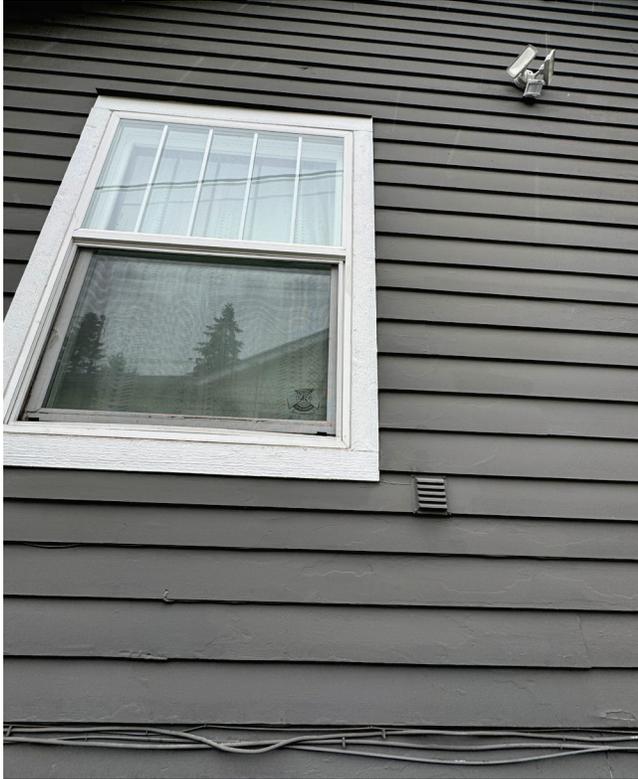
Image of fresh air intake vent (exterior).

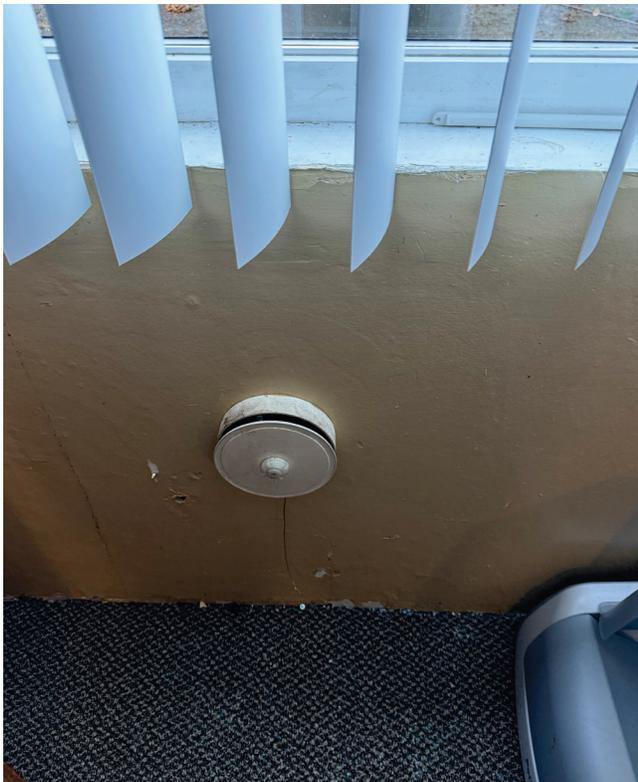
Image of fresh air intake vent (interior).

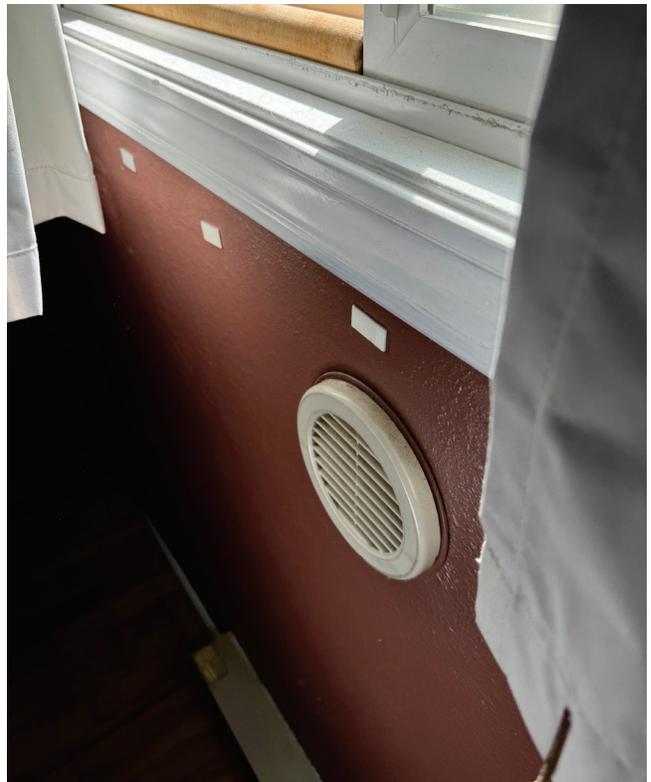
Image of fresh air intake vent (interior).
